CUT GATE PATH

COLLABORATION.
CONSIDERATION.
CONSERVATION.
ACTION?

BACKGROUND

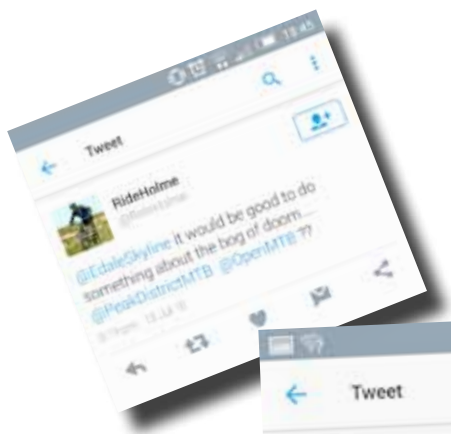
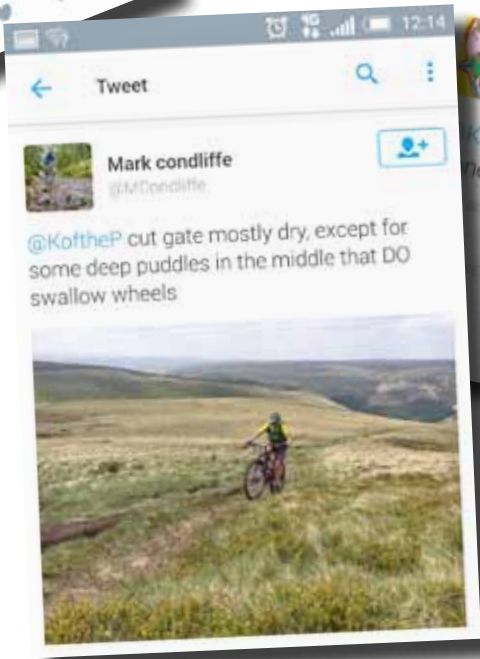
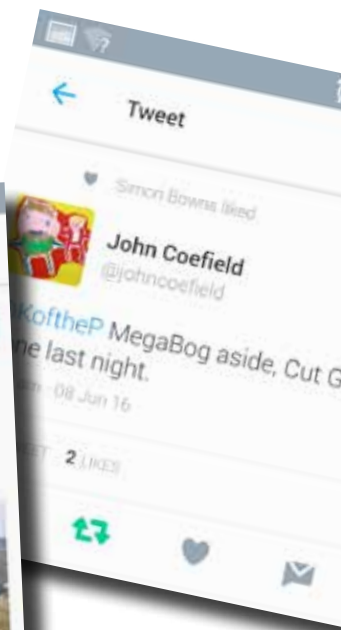
The path fords two tributary streams on high, remote moorland and it is this point where the path often floods.

For those who do head up there, there is clear evidence that many actively avoid travelling through the flooded sections, instead choosing to detour around the marshy or waterlogged area – at times up to 20 metres out on to the heather moorland.

The path is getting wider at this point and as Cut Gate is a honey pot for mountain bikers, they're often unfairly blamed for this perceived damage.

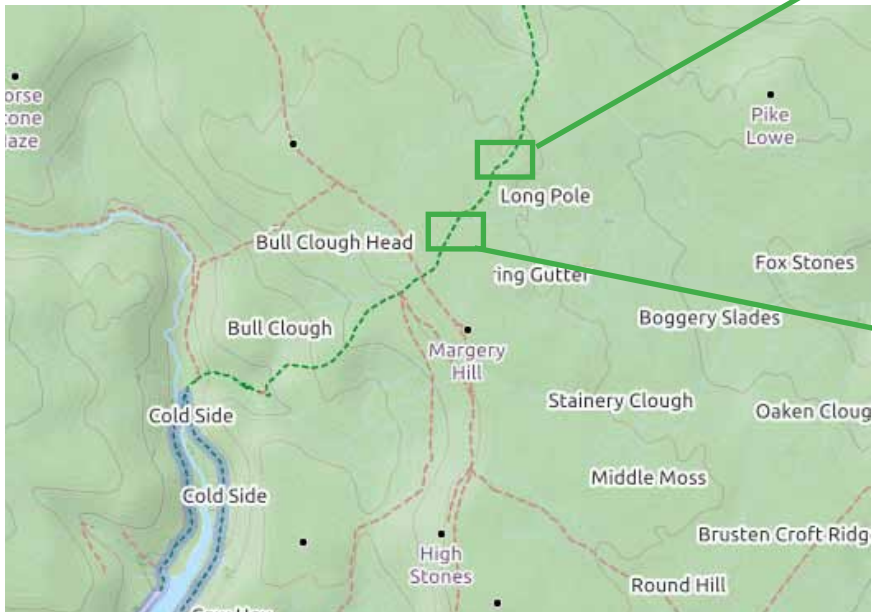
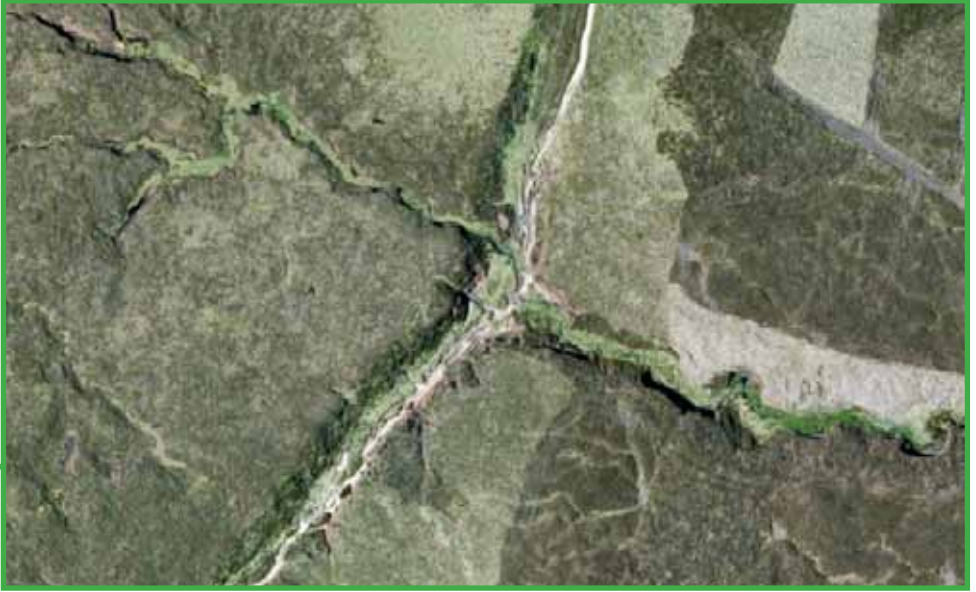
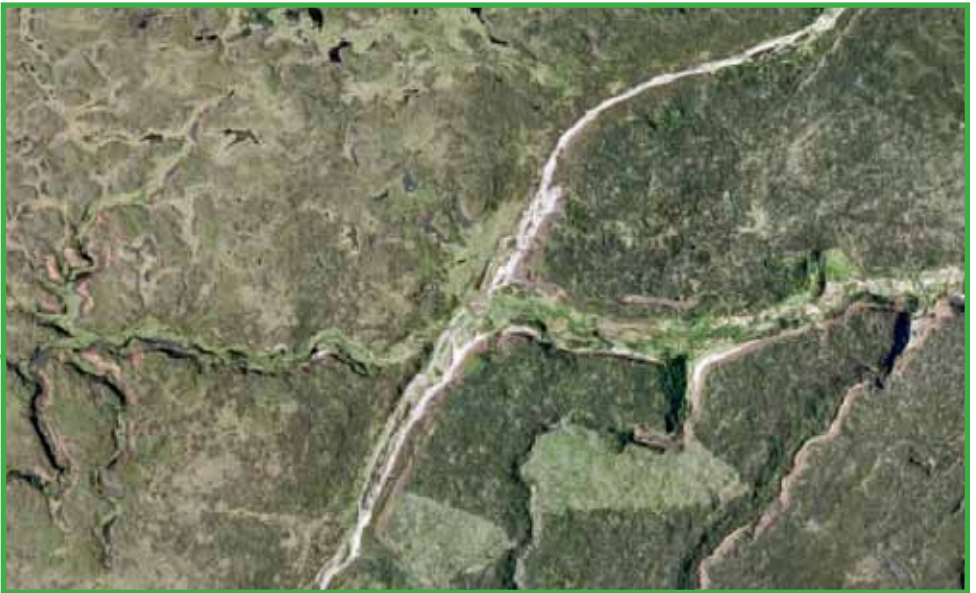
The main areas prone to flooding are two ford crossings on Featherbed Moss, east of Margery Hill on the Cut Gate path.

The bridleway drops to the stream crossing in a natural dip. At the bottom of the dip the stream water backs up regularly resulting in a seemingly impassable bog.

To avoid the deepest part of the flooded area, visitors will often detour around - working their way up or down the streams until they find a narrow enough section to cross.

The aerial views here show the ford areas in question. While you can clearly see a defined line from the north east towards the south west on each picture, it is also clear to see which areas are most prone to flooding.

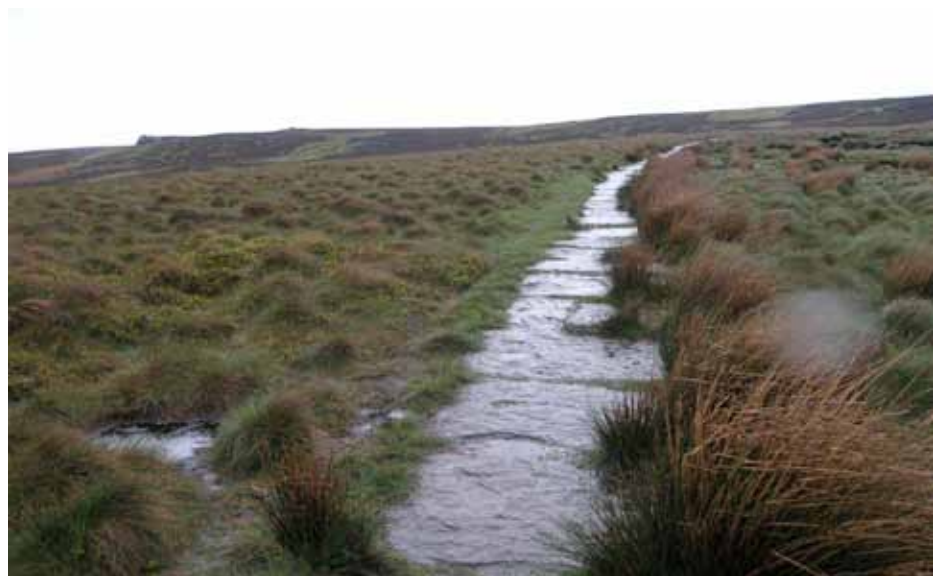
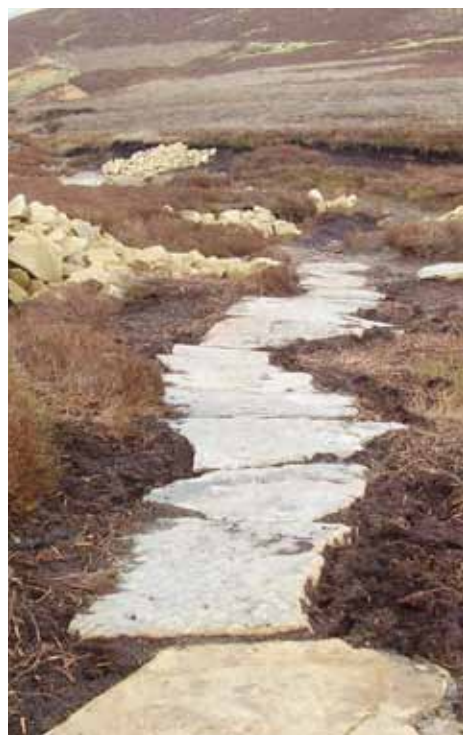
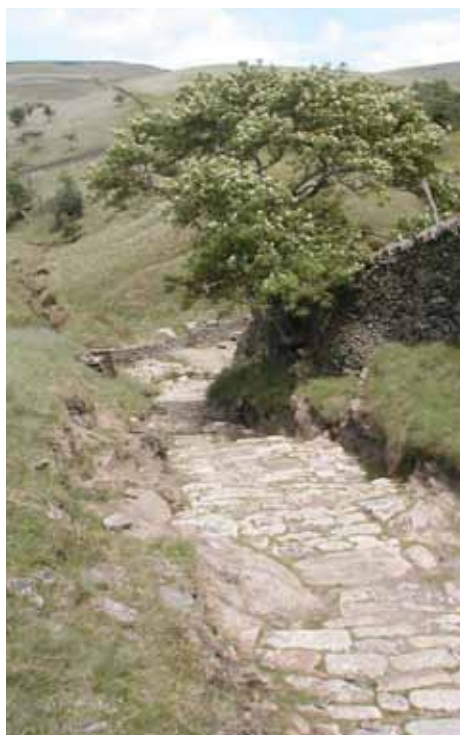
REPAIRS - STONWORK

Slabs, rocks, stepping stones - the choice will entirely depend on the ground conditions/surface - but stone work has been used extensively in the Peak District for hundreds of years; going back to packhorse trails which still last to this day.

More recently, work on the Pennine way and other moorland routes has seen stone used to bridge boggy sections while still leaving channels for water to flow.

Locally sourced, the rocks would over time become part of the landscape.

Offering a resilient, sensitive and sustainable option, stone is popular with a large range of users and seems a good option for these small sections.

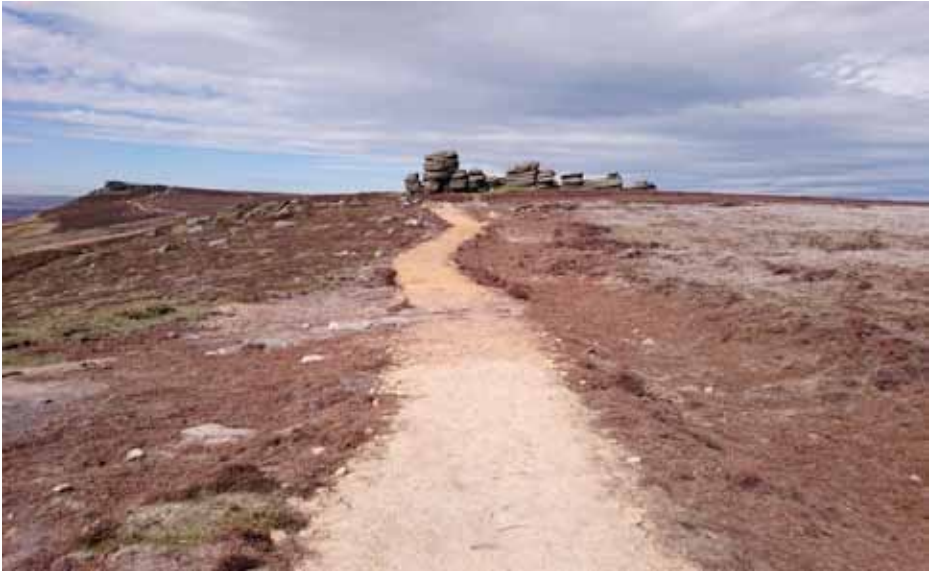
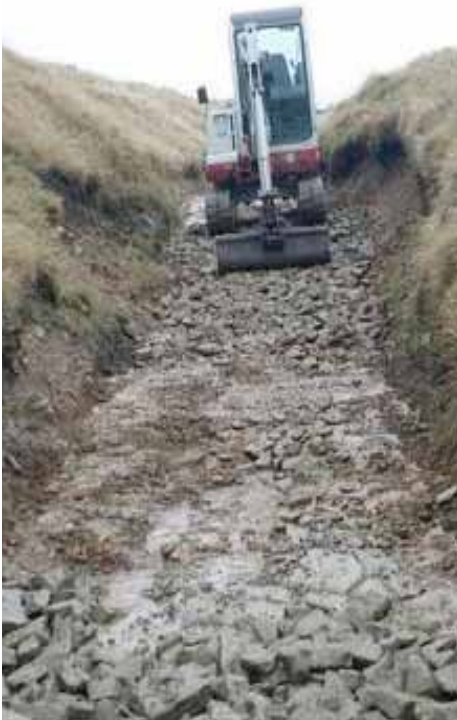
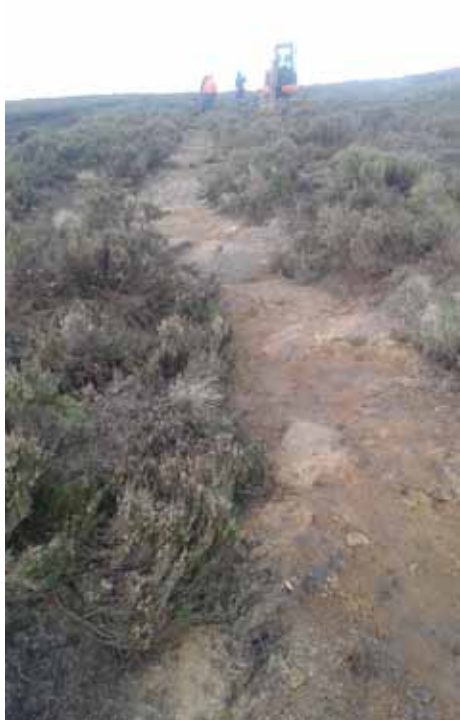
REPAIRS - AGGREGATE

Aggregate surfacing is another common approach to path construction and maintenance in the Peak District. It can be roughly grouped into two groups, using either imported or locally derived stone.

These paths are considered less “natural” than other alternatives. In the case of imported material, this type of surfacing has sometimes received a less than positive reaction from users.

Though the reputation of aggregate work has been affected by recent work on Derwent Edge and elsewhere, it is important to recognise that done well, it can be a suitable surfacing option.

A good example of aggregate used includes the recent resurfacing of Foulstone Road - using locally sourced aggregate and sensitive surfacing techniques.
